# Manhole Inspection Summary

Manhole # S45G2\_022MH

Insp Date: **1/15/08 8:55 AM**

**Location** Address: **4201 Pennington Ave**

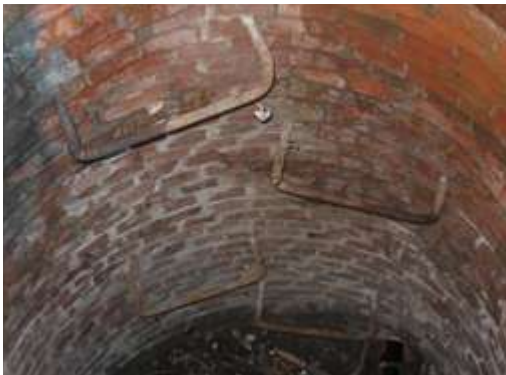
Steps

**Steps** Count: **4** Missing: **0** ☐ Corroded

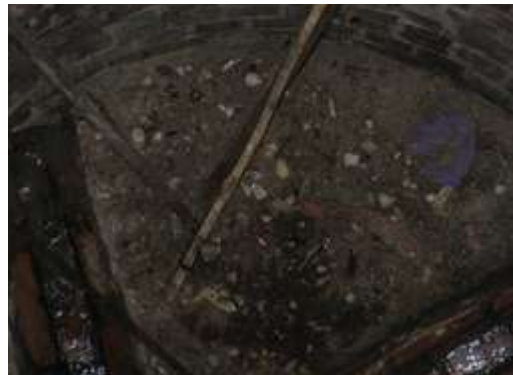
Defect 1

Debris

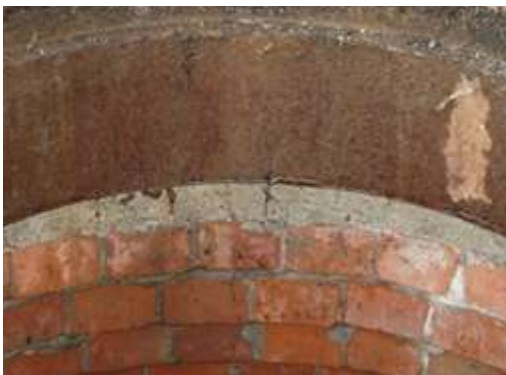
Defect 2

Condition: ☐ Sound ☐ Cracked ☐ Root Intrusion ☒ **Loose Brick** ☐ Deteriorated

Chimney

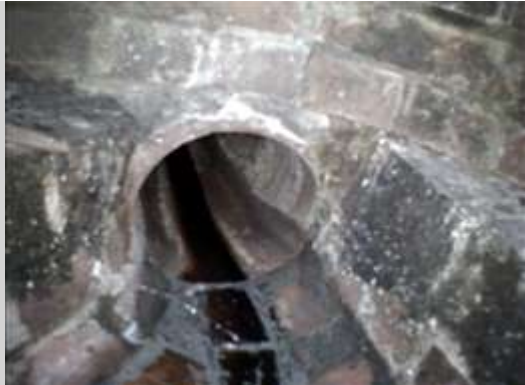
12 O'Clock Outflow

8 in. Circular Gravity Sewer  
Pipe Out @ 12 O'Clock

Pipe Height: **10.8** (in.) Rod and Bar (Angled)  
Pipe Material: **Clay** ☐ Pipe Lined  
Invert Depth: **9.61** (ft.) Flow Characteristics: **Fast**  
Deposits: ☒ None ☐ Mud ☐ Sludge ☐ Debris ☐ Grease  
Silt Depth: (in.) Deposits Extent:  
Infiltration: **None** Pipe Seal Cond: **Sound**

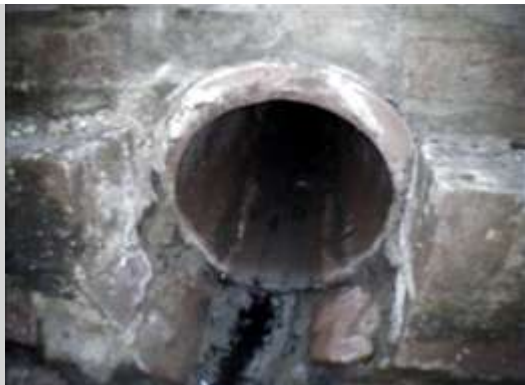
3 O'Clock Inflow

8 in. Circular Gravity Sewer  
Pipe In @ 3 O'Clock

Pipe Height: **9.6** (in.) Rod and Bar (Angled)  
Pipe Material: **Clay** ☐ Pipe Lined  
Invert Depth: **9.17** (ft.) Flow Characteristics: **Fast**  
Deposits: ☒ None ☐ Mud ☐ Sludge ☐ Debris ☐ Grease  
Silt Depth: (in.) Deposits Extent:  
Infiltration: **None** Pipe Seal Cond: **Sound**

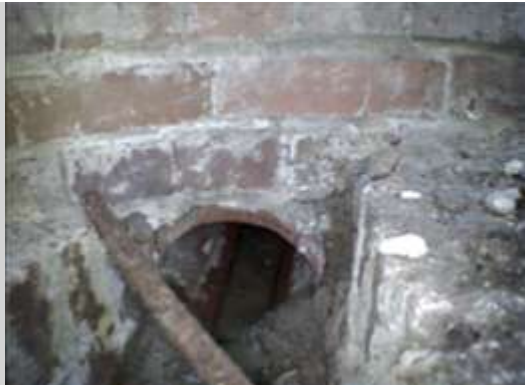
6 O'Clock Inflow

6 in. Circular Gravity Sewer

Pipe In @ 6 O'Clock

Pipe Height: **7.2** (in.) Rod and Bar (Angled)

Pipe Material: **Clay** ☐ Pipe Lined

Invert Depth: **9.23** (ft.) Flow Characteristics: **None**

Deposits: ☒ None ☐ Mud ☐ Sludge ☐ Debris ☐ Grease

Infiltration: **None**

Pipe Seal Cond: **Sound**

Connects To: **House connection / Service line**

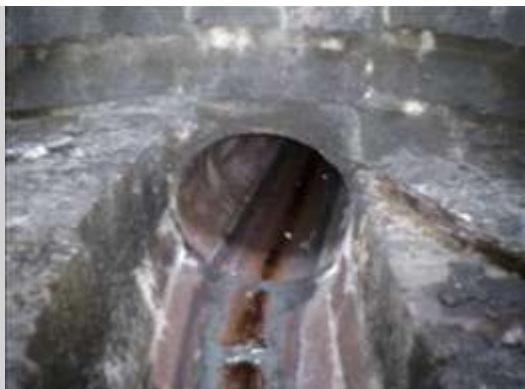
9 O'Clock Inflow

8 in. Circular Gravity Sewer

Pipe In @ 9 O'Clock

Pipe Height: **9.6** (in.) Rod and Bar (Angled)

Pipe Material: **Clay** ☐ Pipe Lined

Invert Depth: **9.17** (ft.) Flow Characteristics: **Fast**

Deposits: ☒ None ☐ Mud ☐ Sludge ☐ Debris ☐ Grease

Infiltration: **None**

Pipe Seal Cond: **Sound**
